**Planning Assistance to States – Brush Creek Low Water
Crossing**

Mission Hills, Kansas

**US Army Corps of Engineers
Kansas City District**

March 2020

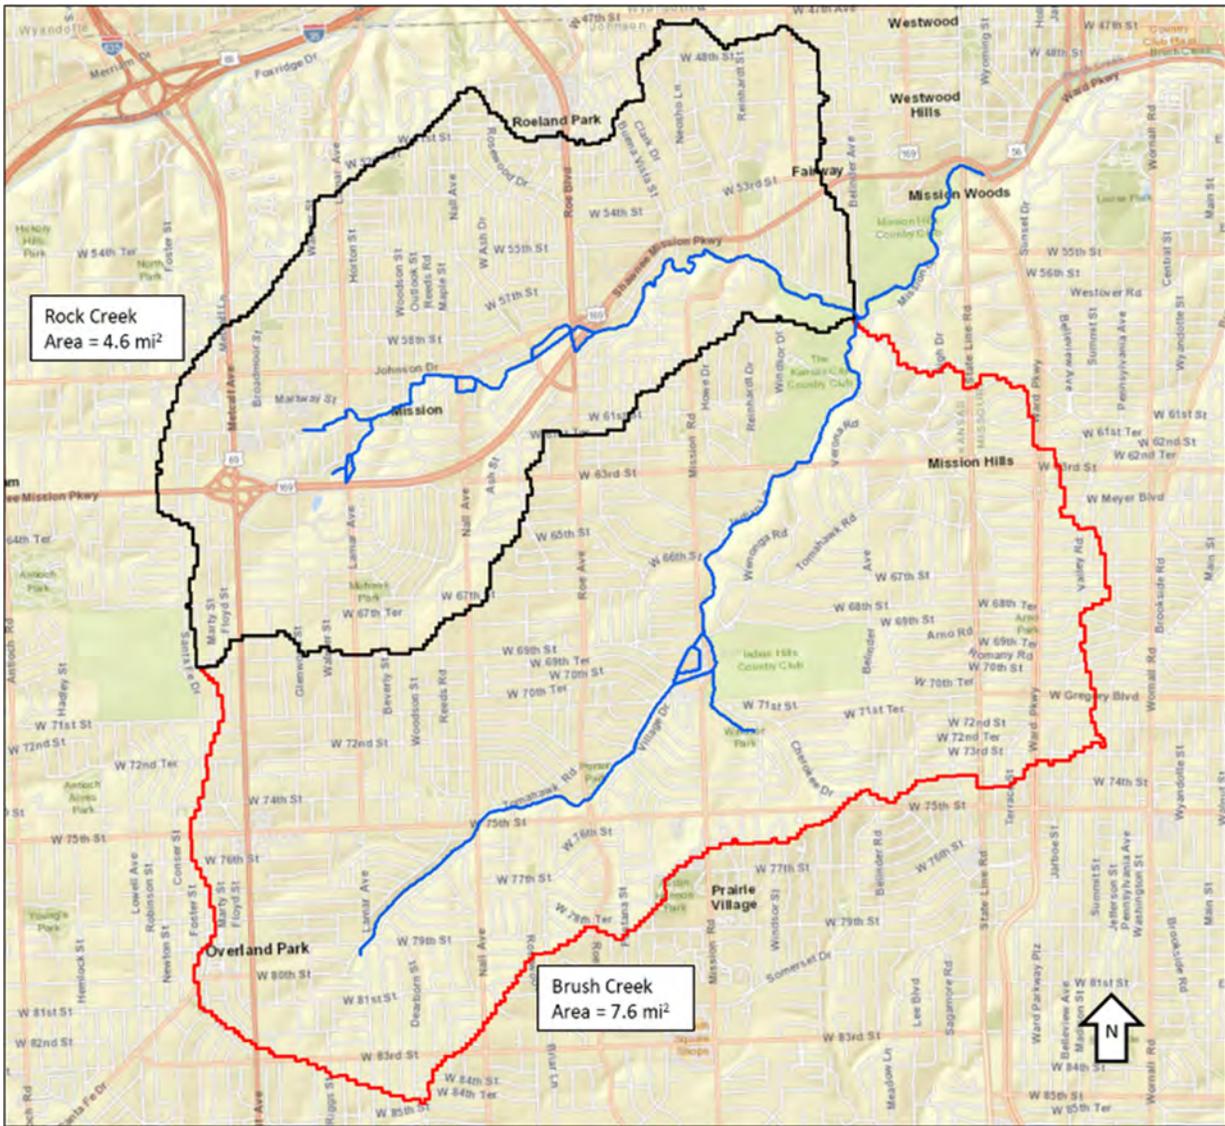
Figure 1 - Rock and Brush Creek Basins

The attention of this study is focused on the confluence of Rock Creek and Brush Creek. These creeks are entirely urbanized and are known to be flashy. Rock Creek's headwaters are west of Mission, KS in Overland Park, KS while Brush Creek begins farther south in Overland Park, KS. Each creek has sections of natural channel bed, concrete channel, and grade control structures.

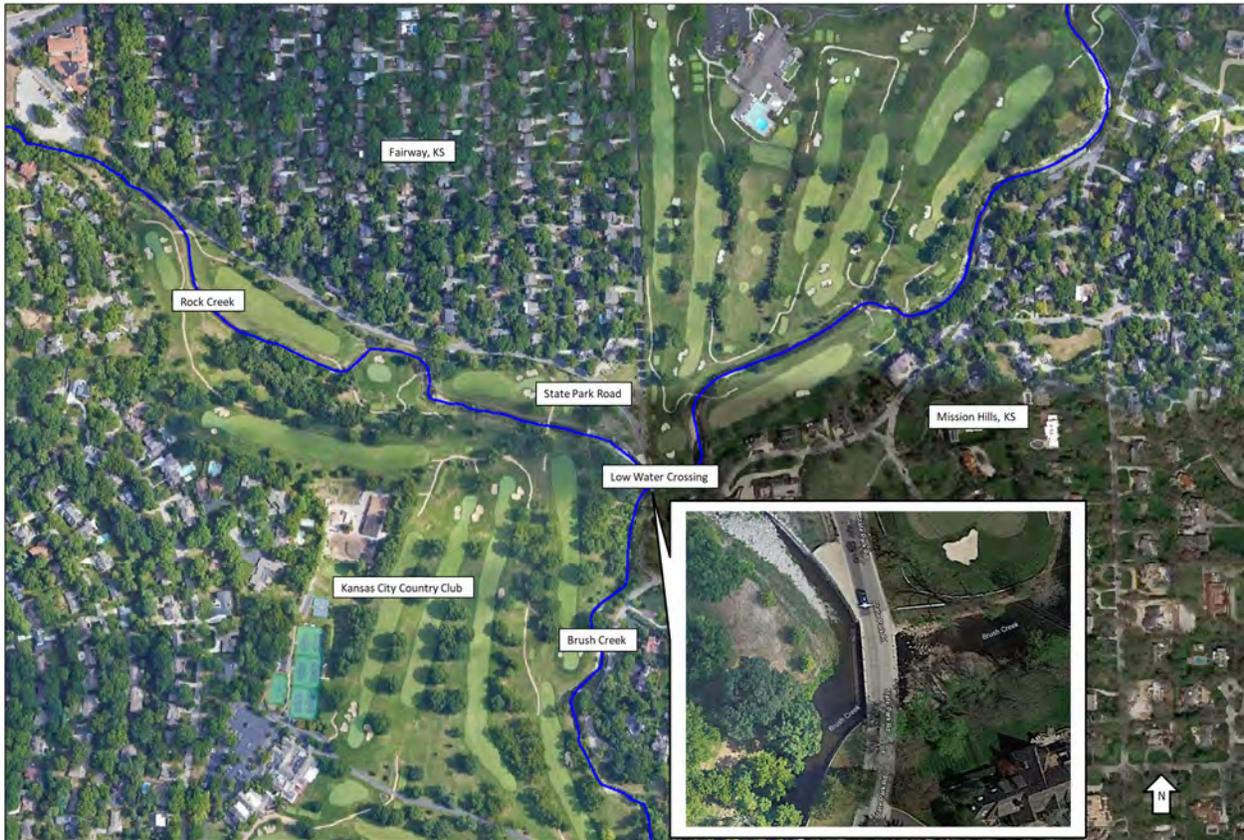
Figure 3 – Detailed Study Area

The detailed study zone is outlined in Figure 3.

The channels in the detailed study area are less confined than in the upper portions of the basin. The stream banks are frequently overtopped in this portion of the basin. Numerous residential buildings are in the FEMA 10-year floodplain. There are four houses effected by the FEMA 100-year flood in this reach, three in Fairway and one in Mission Hills. One house in Fairway and the house in Mission Hills are also inundated by the 10-year FEMA flood. There are many low water crossings along both creeks that frequently overtop; some have a functioning automated warning system and others must be closed using city emergency response personnel.

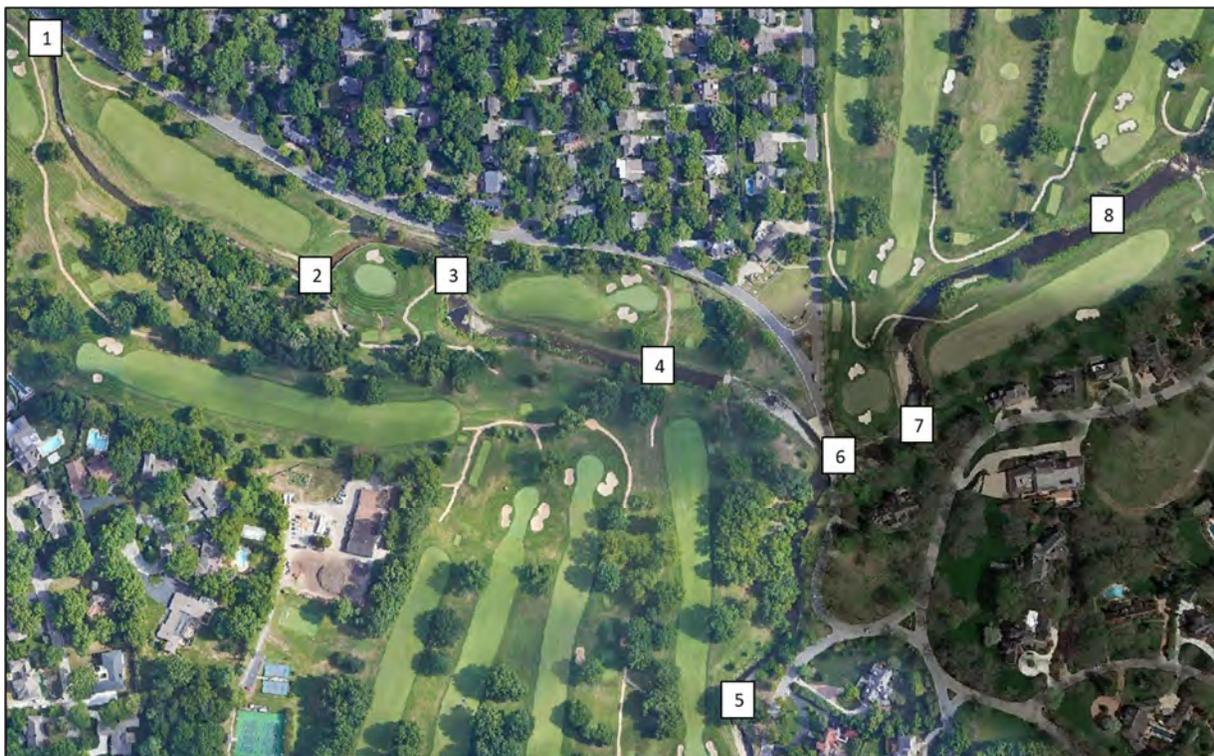
Figure 4 – FEMA vs USACE Output Locations

Table 2 summarizes water surface elevations from the USACE hydraulic analysis as well as water surface elevations from the FEMA effective model. Figure 4 demonstrates the output locations found in Table 2. The 100-year max flood extent is shown in Figure 5.

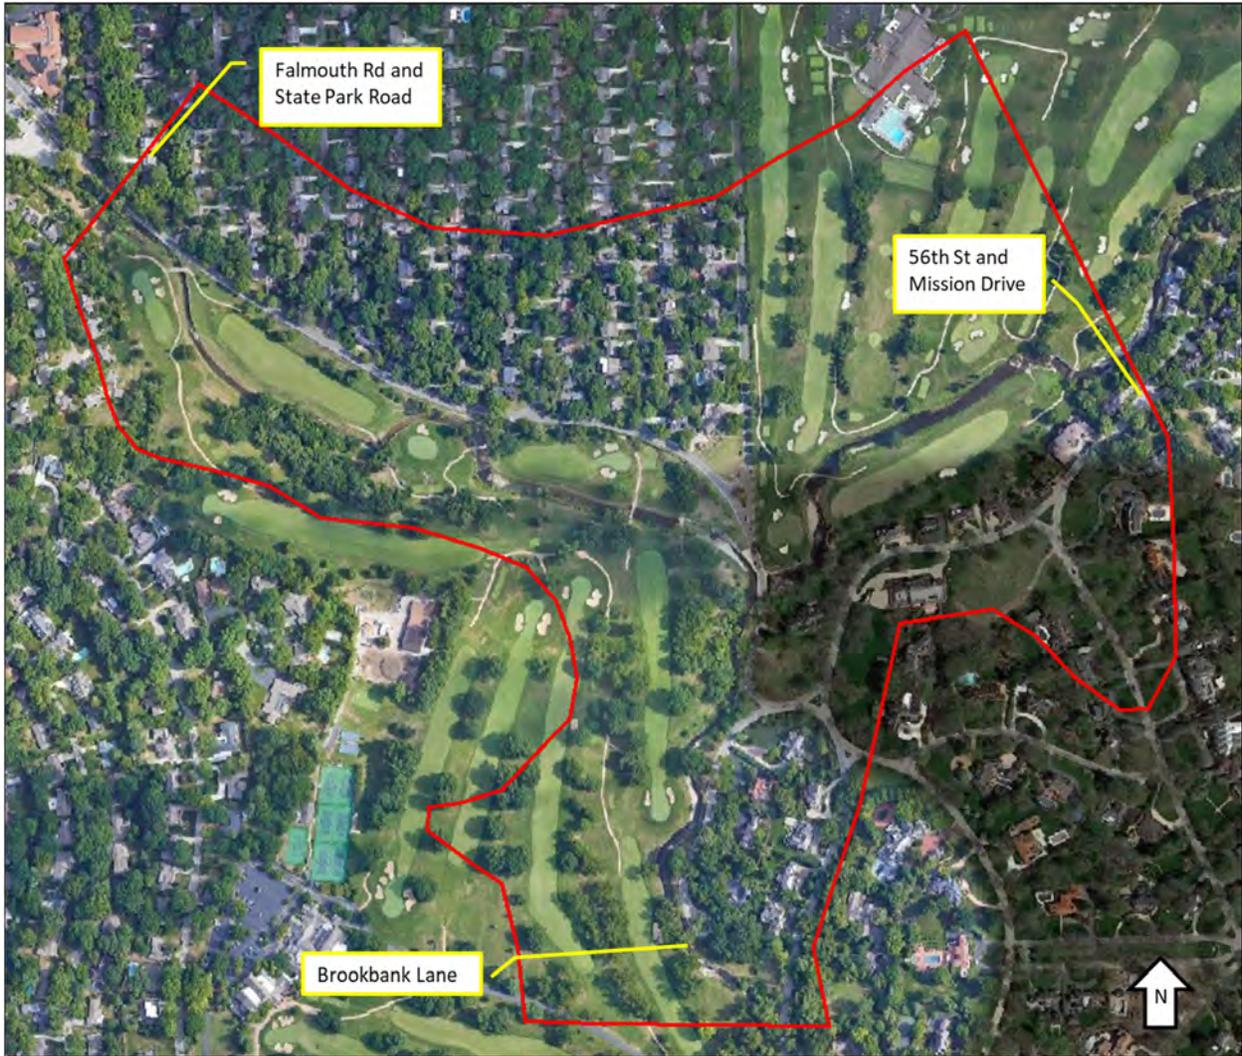
Figure 6 – 2D Perimeter

2D HEC-RAS model was limited to the same extents as the physical model constructed by Water Resource Solutions. Figure 6 shows this extent.

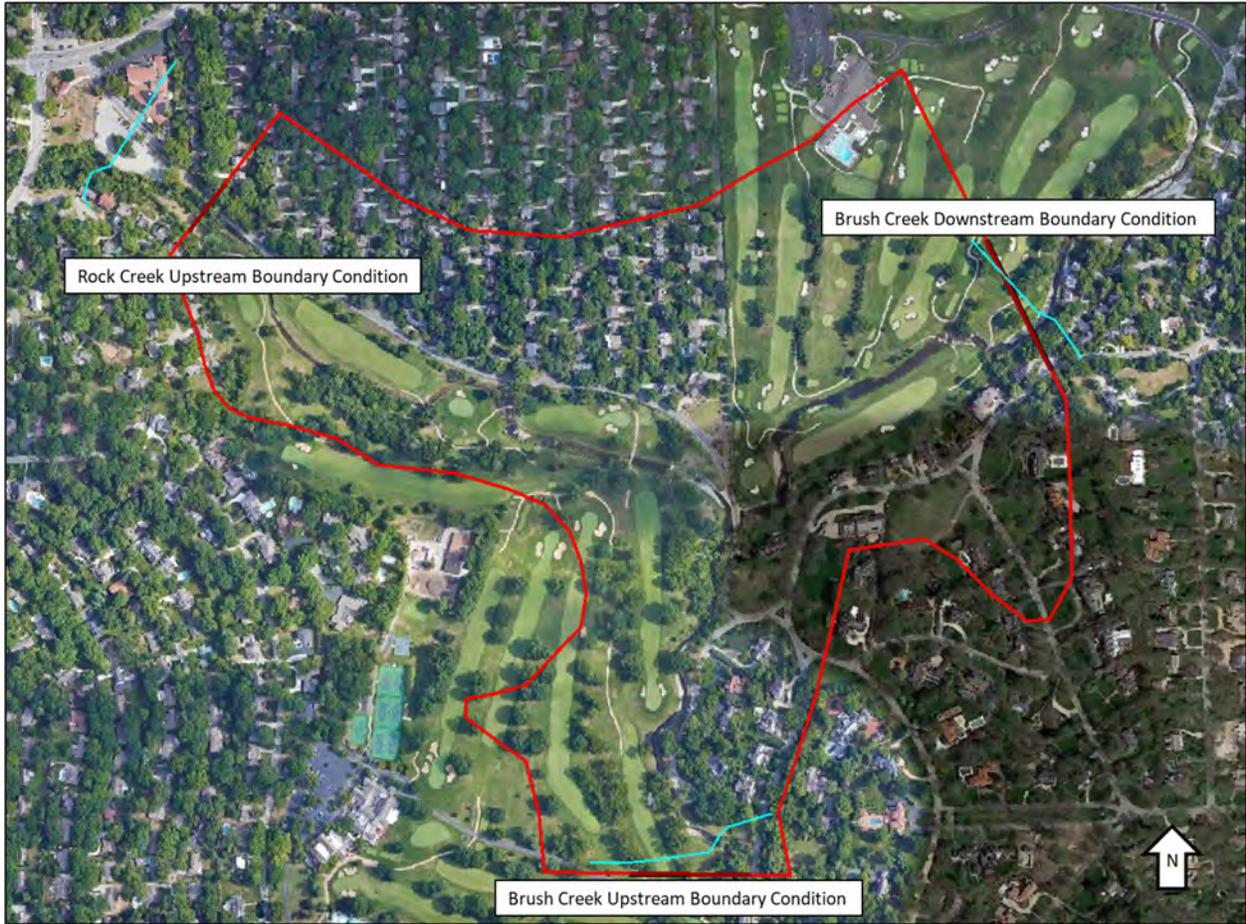
Figure 7 – 2D Model Boundary Conditions

Upstream boundary conditions for the 2D model were taken from the closest flow change location in FEMA’s steady HEC-RAS model. These flow change locations and their proximity to the 2D boundary are shown in Figure 7.

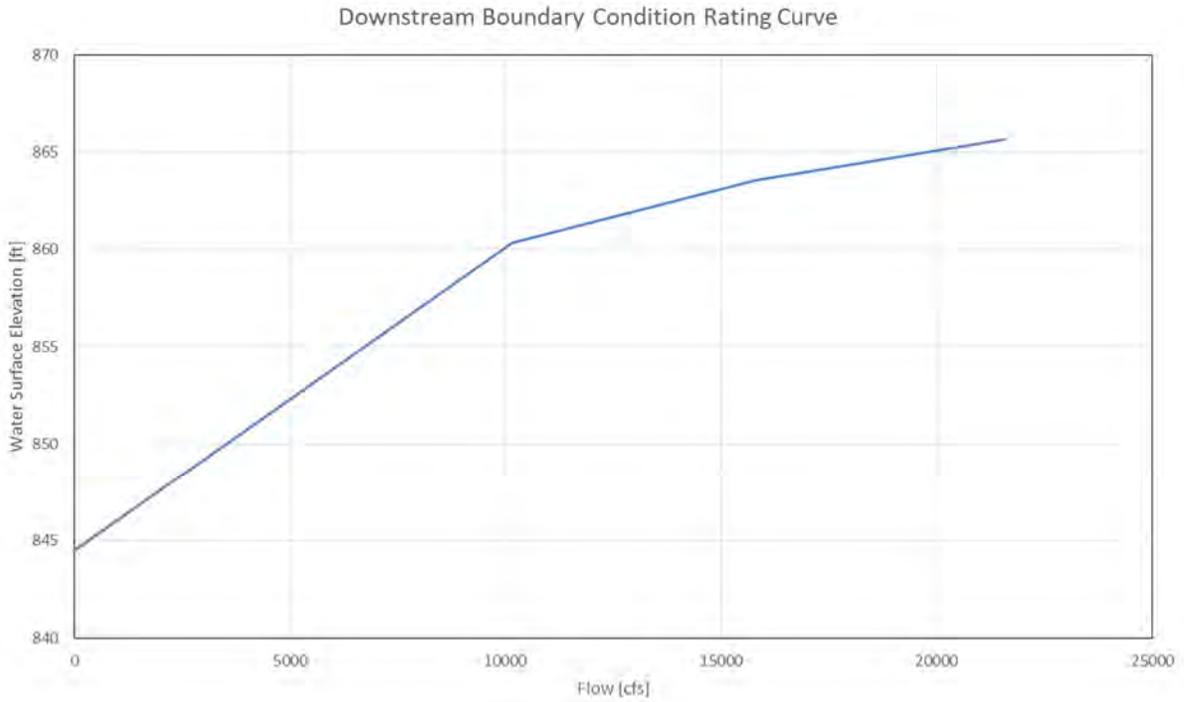
Figure 8 – Downstream Boundary Condition Rating Curve

The rating curve used for the downstream boundary condition is shown in Figure 8.

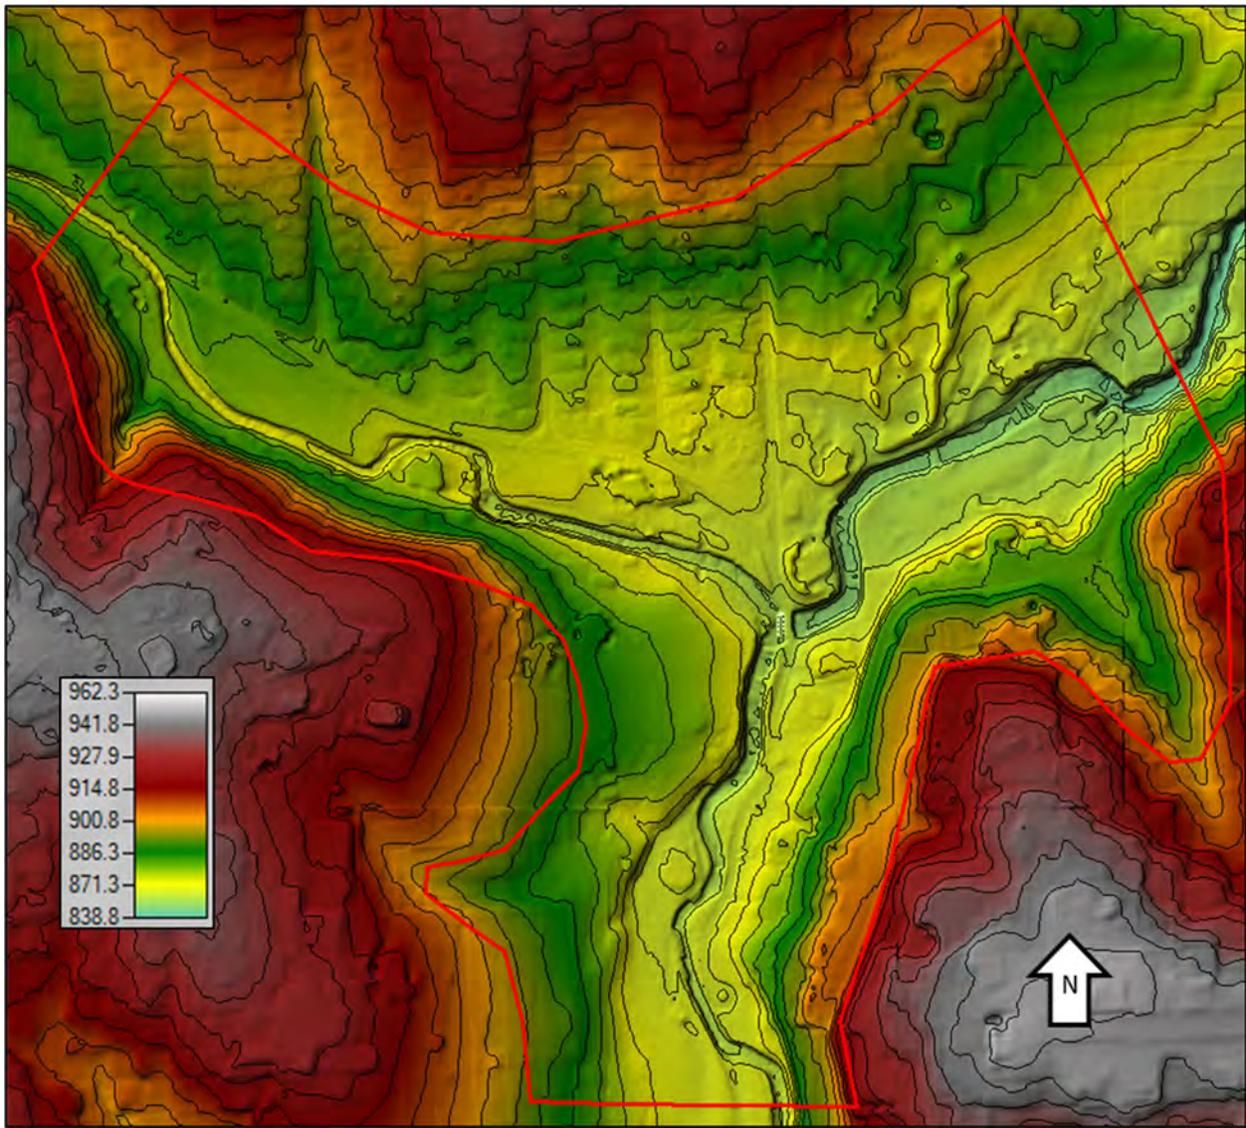
Figure 9 – Existing Condition Terrain with 5-ft contours

The terrain model is a major component of a 2D hydraulic model. The existing condition terrain model used in this study consists of a 1-foot LiDAR data set obtained from Water Resource Solutions combined with 2012 State of Kansas GIS DASC LiDAR. The elevations just upstream and downstream of the low water crossing were lowered to allow HEC-RAS to place the low water crossing at its proper invert and outlet elevations. Figure 9 shows the overall existing conditions terrain model plotted with 5-foot contours.

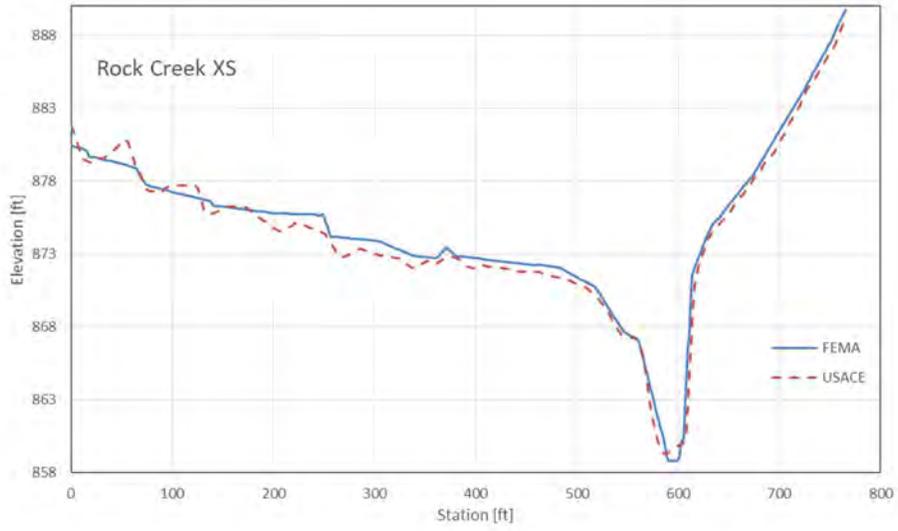
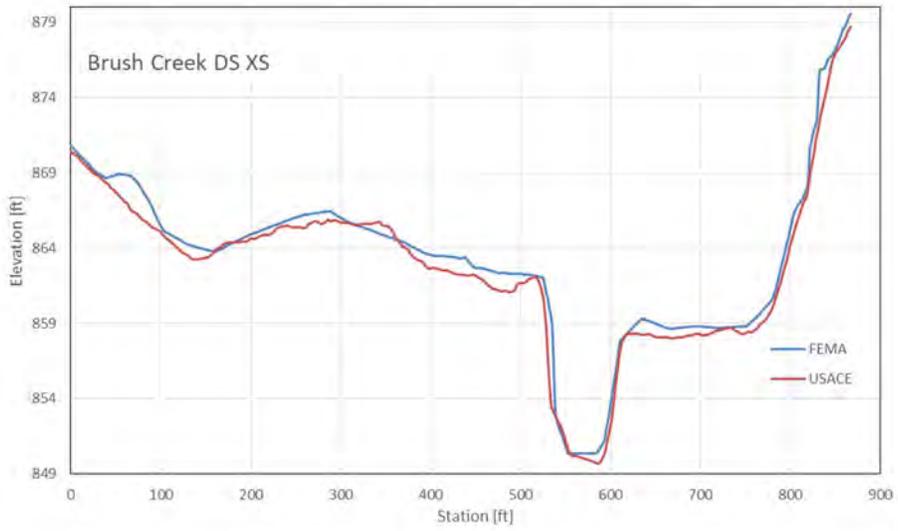
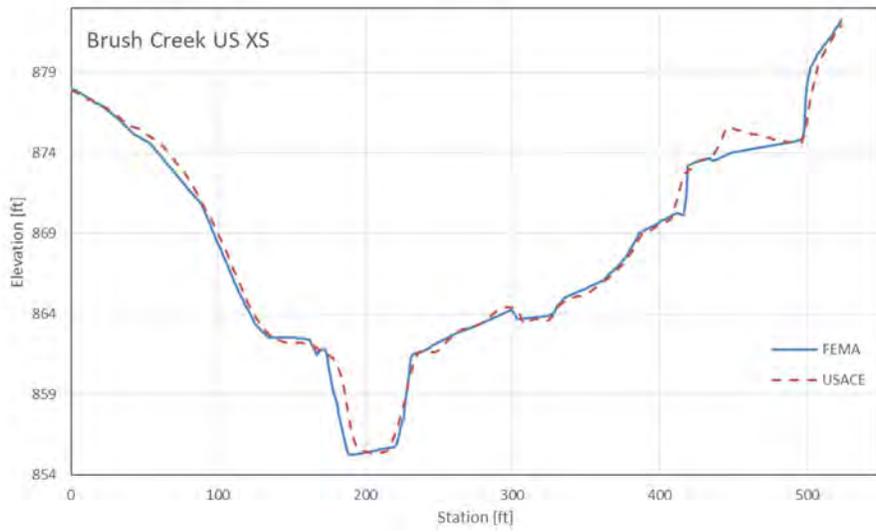
Figure 11 – FEMA Cross Section vs. USACE Terrain Comparison

As part of a general investigation of the data available, the terrain used in the USACE model was compared to the cross sections used in the FEMA model. The USACE terrain and FEMA cross sections, with focus on the channel sections, are consistent with each other. Example cross sections for each reach are shown in Figure 11.

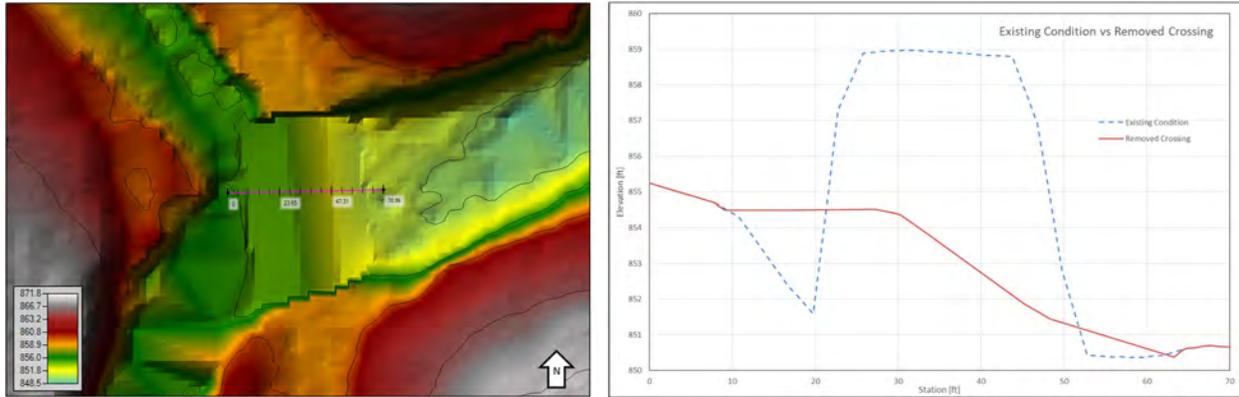
Figure 12 – Terrain showing removed Low Water Crossing

A second terrain model was used to model an alternative in which the low water crossing is completely removed. Figure 12 shows the removed low water crossing as well as a profile plot of the removed crossing.

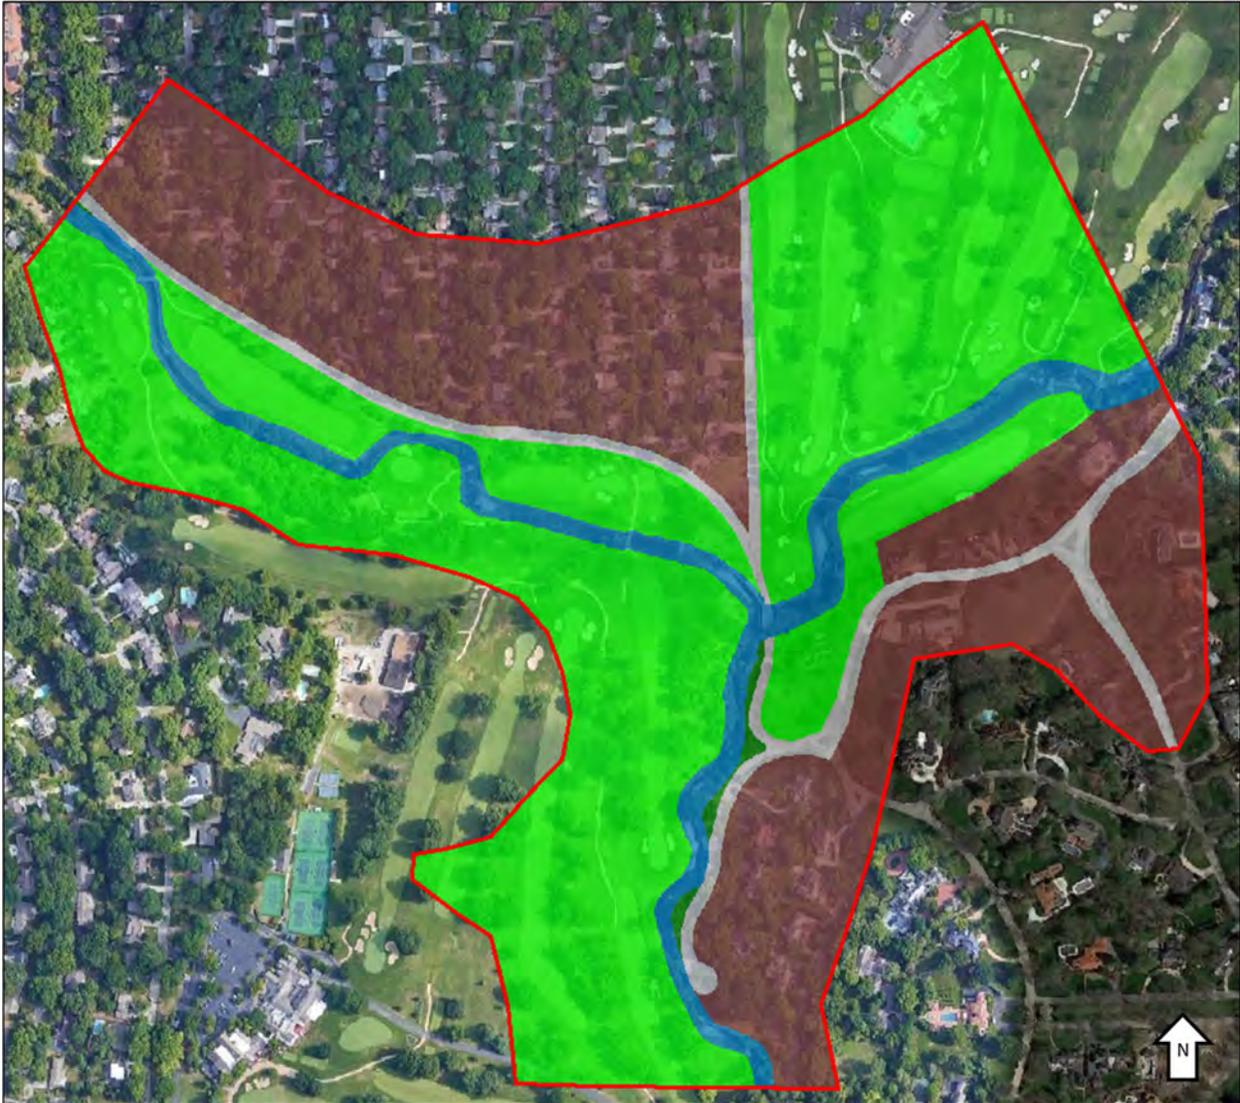
Figure 13 – Manning Roughness Zones

Roughness zones were delineated using aerial imagery. Roughness values were determined using engineering judgment. Calibration of roughness values was not possible due to lack of information. Figure 13 and Table 4 summarize the Manning roughness zones and values used in the 2D model.

Roughness Zone	Value Used	Sensitivity
Channel	0.0375	0.03
Golf Course	0.045	0.035
Grass	0.05	0.0375
Residential	0.06	0.04
Road	0.02	0.01

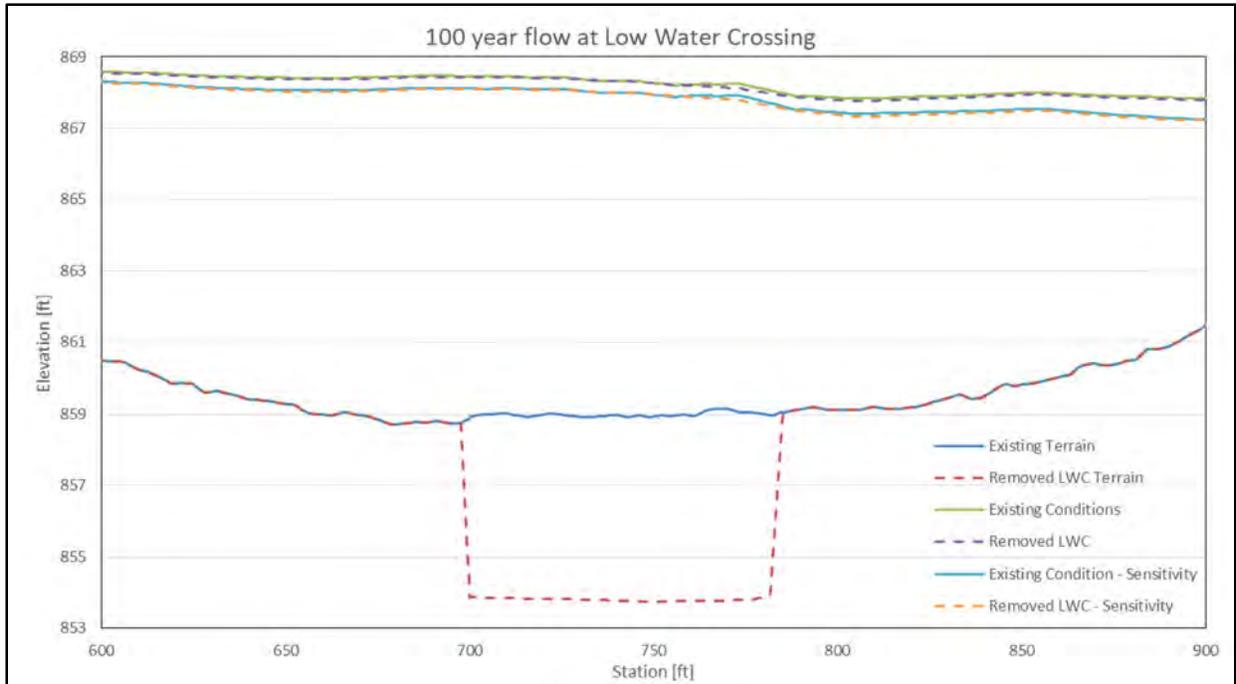
Figure 14 – Sensitivity Analysis at Low Water Crossing for 100-year flow

In lieu of calibration data a sensitivity analysis was run on existing conditions and the removal of the low water crossing alternative. The water surface elevations for the existing condition, using the sensitivity values, were on average 0.5 feet lower than the values used for this study. The differences between the sensitivity existing conditions and the sensitivity removed low water crossing are the same, therefore the conclusions of this study and the Flood Problem Rating table would be the same. The difference in roughness had a negligible effect on inundation boundary. Velocities differed, ranging from 0.2 fps to 0.8 fps. Figure 14 is a cross section taken on top of the low water crossing, looking downstream. It shows the difference between the existing conditions and the removed low water crossing for chosen roughness values as well as the sensitivity test.

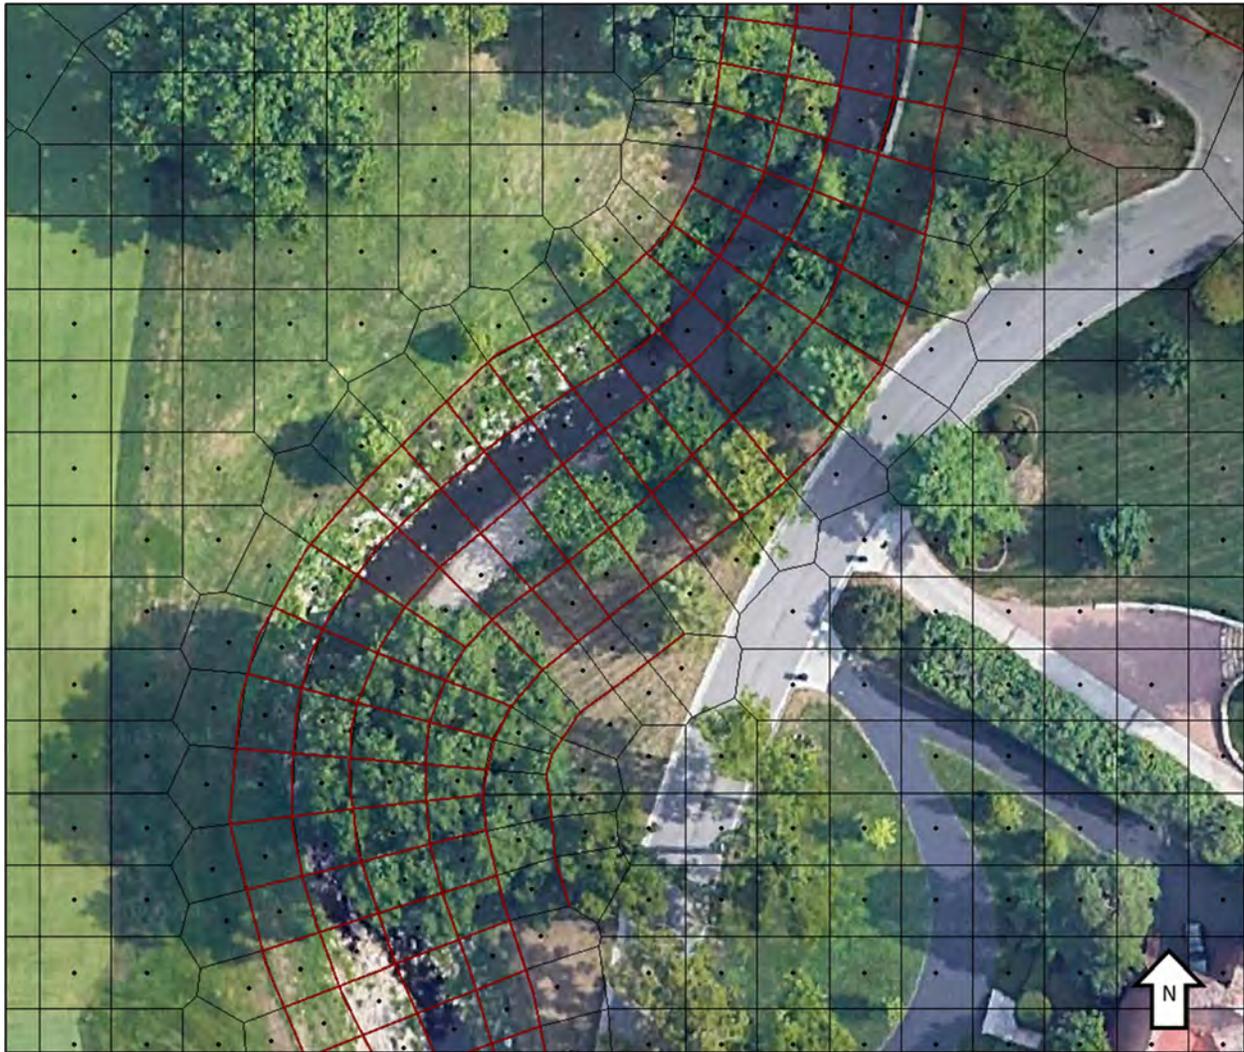
Figure 15 – 2D Mesh Example

The 2D HEC-RAS mesh consist of a 20-foot nominal cell size, breaklines and internal hydraulic structures. Breaklines were longitudinal and latitudinal to the channel. This aligns cell faces in the direction of flow which helps model stability when using the full momentum equations. Figure 15 shows an example of the mesh and breaklines along Brush Creek.

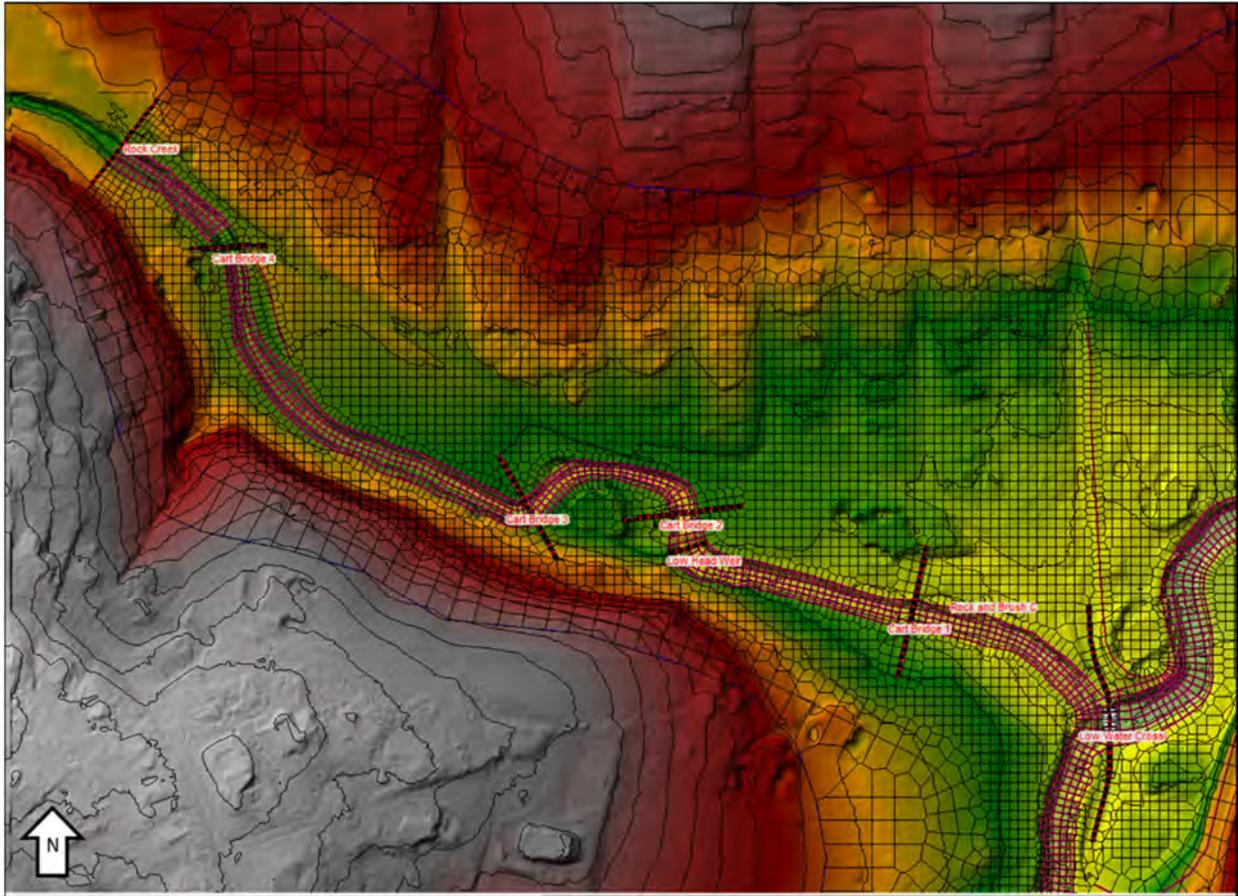
Figure 16 – 2D Internal Hydraulic Structures

Internal hydraulic structures are another major portion of this mesh. There are six total structures modeled. Four golf cart bridges and a low head weir that are found in the FEMA model as well as the low water crossing, the focus of this study. The internal structures were set to use the 2D equations for overtopping flow. The golf cart bridges were input as box culverts because HEC-RAS 2D does not currently support bridge structures within the 2D mesh. The dimensions of their openings were taken from the FEMA model. The average span is 40 foot and the rise is 8 foot; a 0.012 Manning's n was used as the culvert bottom. The low head weir was set to elevation 864.00 ft, the same as the FEMA model. Figure 16 shows the five structures along Rock Creek.

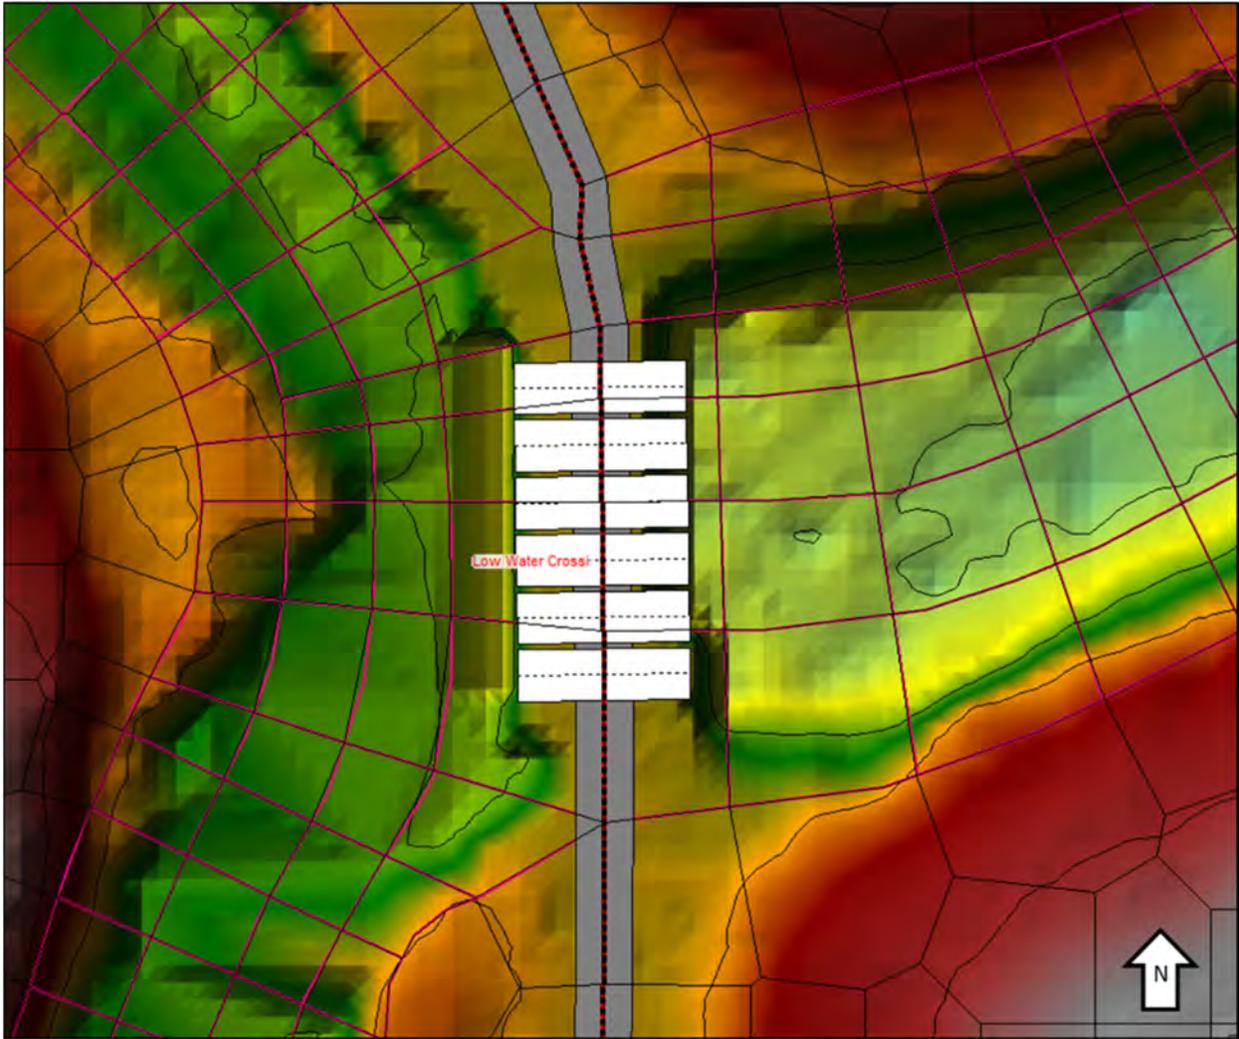
Figure 17 – Low Water Crossing in 2D mesh

The low water crossing was input using the Black and Veatch design drawings obtained from Water Resource Solutions. The culvert invert, outlet, bridge deck, and barrel size match the design drawings. The culvert roughness was set to 0.015. Figure 17 and Figure 18 show low water crossing in the mesh and internal structure editor.

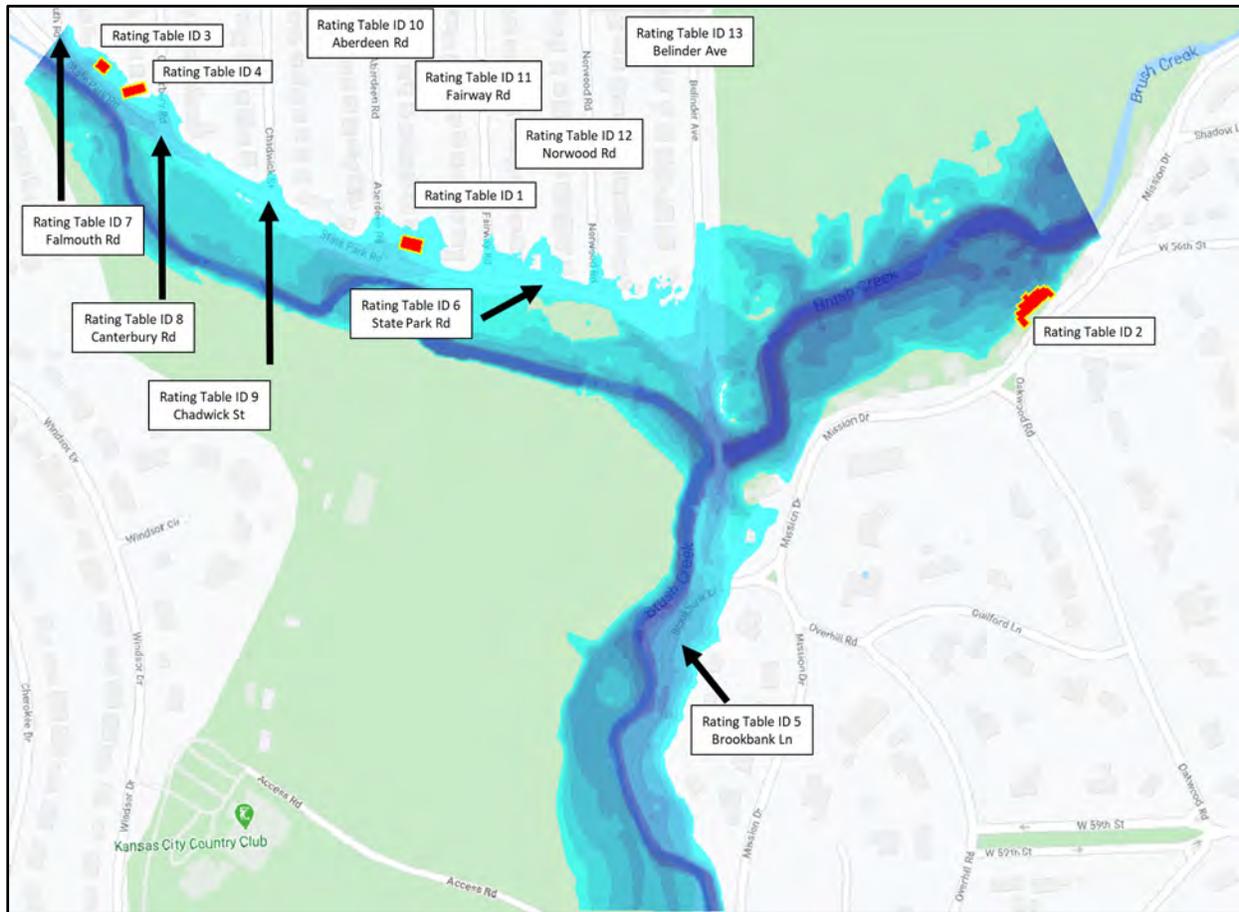
Figure 19 – Location of Buildings and Streets in Flood Rating Table

Three alternatives were investigated for this study: 1) A house buyout, 2) removal of the low water crossing, and 3) removal of the low water crossing as well as raising State Park Road. This section will contain a brief description of each alternative and their cost estimate. Figure 19 and Table 5 summarize and demonstrate the location of each ID in the Flood Problem Rating Table.

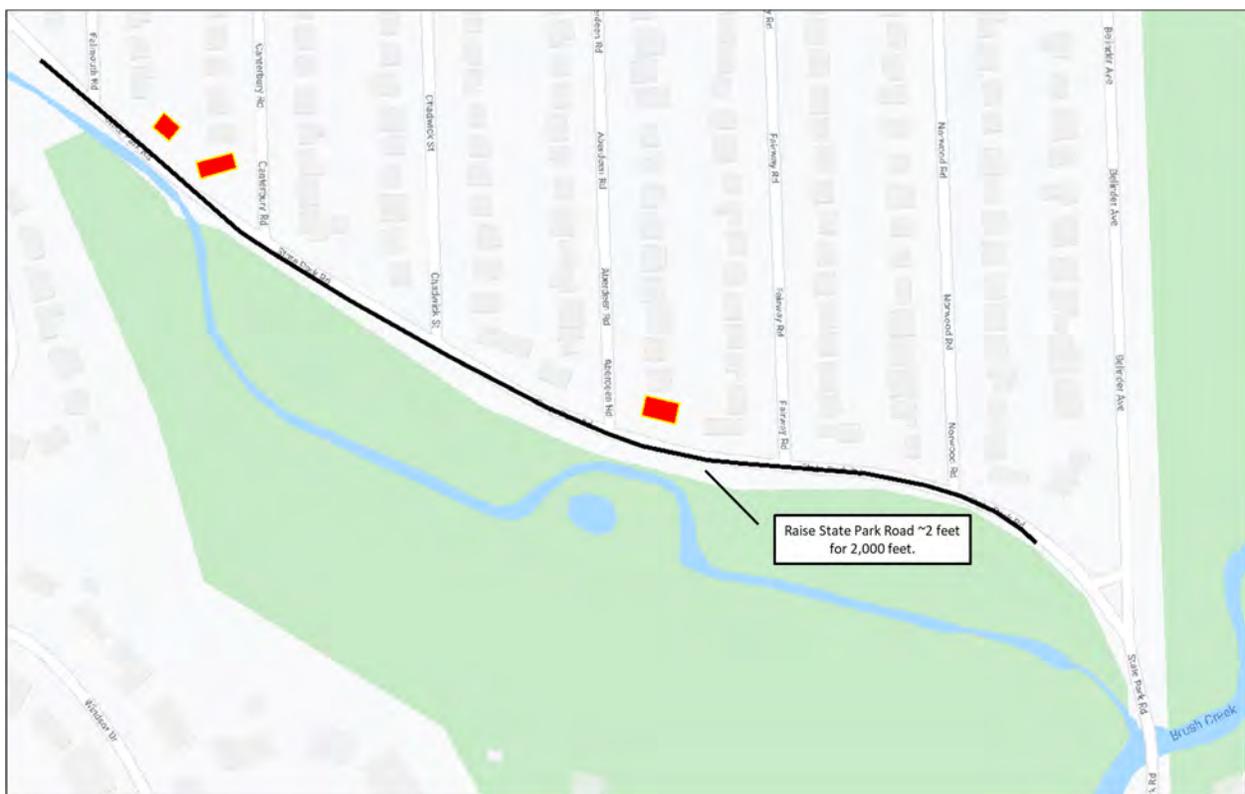
Figure 22 – Potential Location of State Park Road Raise

This alternative includes the measures in the Remove Low Water Crossing alternative and adds a raise of State Park Road. In the existing condition State Park Road, and subsequently 3 houses along State Park Road, flood during the 10-year FEMA flow. In the FEMA 100-year flow these houses are inundated by about 2 feet of water. This alternative would raise State Park road by two feet to take State Park Road and 3 houses out of the 100-year FEMA flood. Raising State Park Road would also take Brookbank Lane, Falmouth Road, Canterbury Road, Chadwick Street, Aberdeen Road, Fairway Road, and Norwood Road out of the FEMA 100-year flood. An update to the stormwater drainage system is included for the aforementioned roads since they would now need to drain under the newly raised State Park Road. Figure 22 shows the potential location of the State Park Road raise. Table 10 contains a cost estimate for this alternative. Table 11 and Figure 23 summarize the Flood Problem Rating table for this alternative.

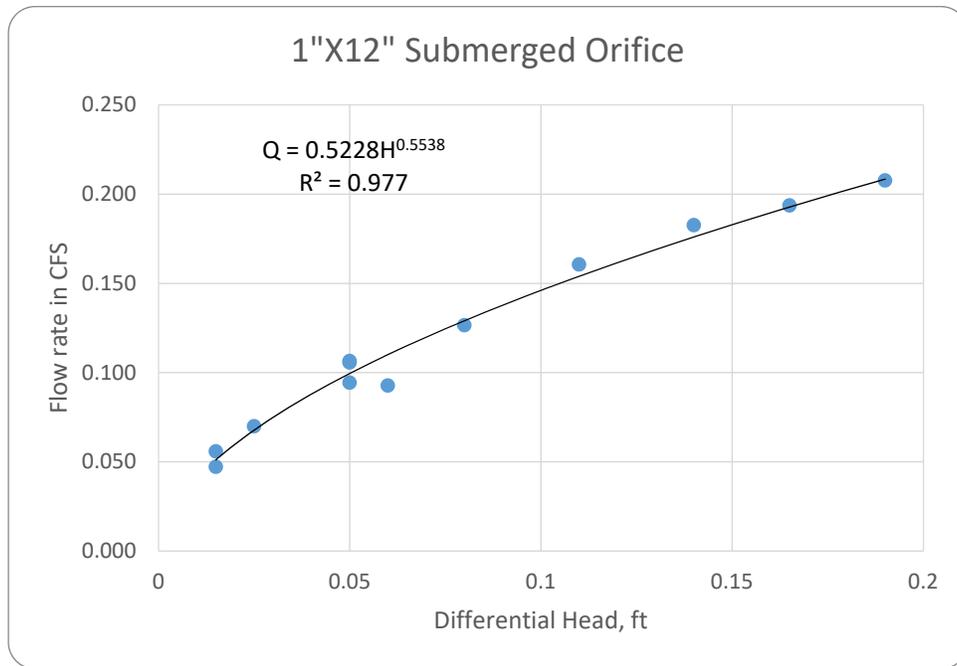
The Results of this calibration are presented in Figure 1, showing the calibrated flow equation.

Figure 1. Flow equation for submerged orifice, Brush Creek Headbox.

The model was built to study the confluence of Brush and Rock Creek in Mission Hills, KS and consisted of a rigid scale model, with gravel streambed. Water to the model was pumped from the existing below ground tank located in Room 113 of Flarshiem Hall on the UMKC Campus. After the pump, the flow was split into two 3-inch diameter supply lines to provide water to the head boxes for Brush Creek, and Rock Creek. Flow control for each was provided with separate gate valves. Flow measurement for the Rock Creek headbox was determined by a 3"x1.5" venturi meter. For the Brush Creek Headbox a submerged orifice was built into the headbox. Submerged orifices are well described in the US Bureau of Reclamation's Water Measurement Manual. The Headbox submerged orifice deviated slightly from the standard in the measurement manual and therefore was calibrated before laboratory testing against the 3"x1.5" venturi.

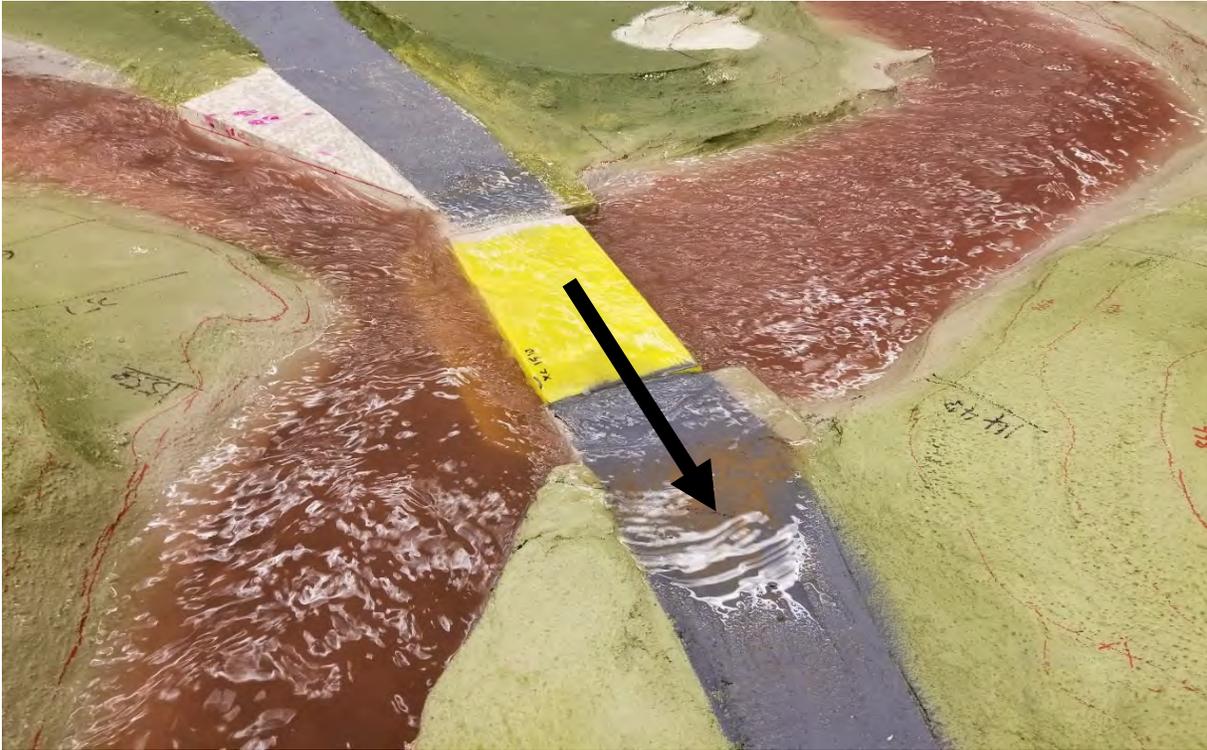
With a larger contribution of flow from Rock creek, the flow characteristics are significantly different. In this case supercritical Rock creek flows formed a hydraulic jump near where the hydraulic jump formed in Run1 however the sub- and supercritical flows were reversed. The Rock creek flow was super critical and Brush creek was subcritical. This is opposite of what happened when Brush creek was more dominant. Instead of flowing diagonally over the left approach to the bridge, a portion of the flow from Rock creek flowed parallel over the bridge from the near the left abutment to an area beyond the right abutment (Figure 2). A hydraulic jump perpendicular to the long axis of the bridge is clearly visible in the right approach roadway. Chads sprinkled on the flow clearly show this behavior (Run2b.mp4).

Figure 2 With Rock creek, dominate water overtops and runs east on road forming a hydraulic jump (near head of arrow) on the right roadway approach.
