**Planning Assistance to States – Brush Creek Low Water
Crossing**

Mission Hills, Kansas

**US Army Corps of Engineers
Kansas City District**

March 2020

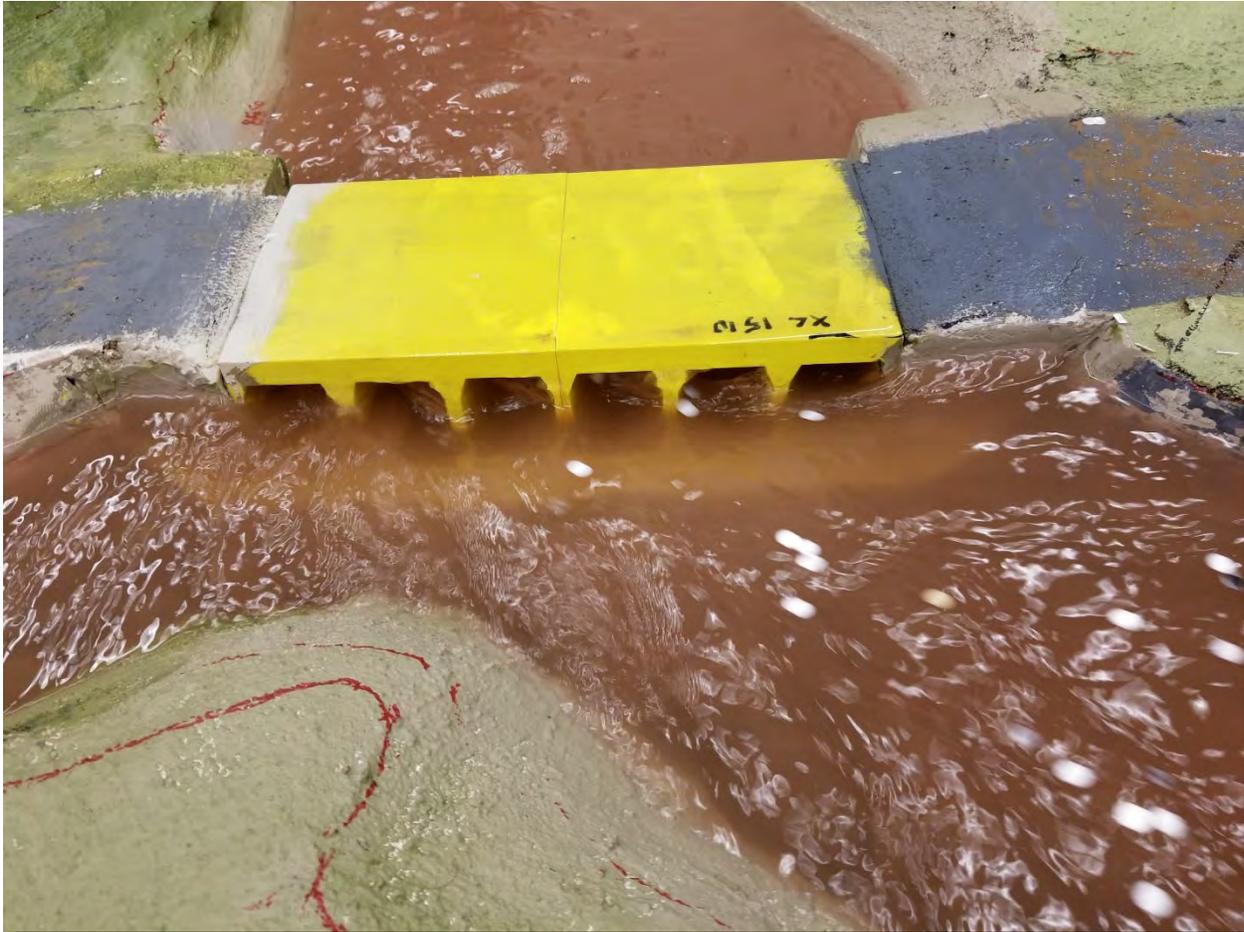
With the culvert and road the flow from Brush creek sweeps parallel to the weir as the weir acts more like a side channel spillway. Most of the flow is concentrated in the culvert barrel furthest to the left of the structure. Downstream of the culvert on the right side there is a large area of slack water (Figure 3).

Figure 3. With no flow from Rock creek the flow from Brush creek sweeps across weir and flows through the left culvert barrels. Downstream there is dead water on the right side of the channel.

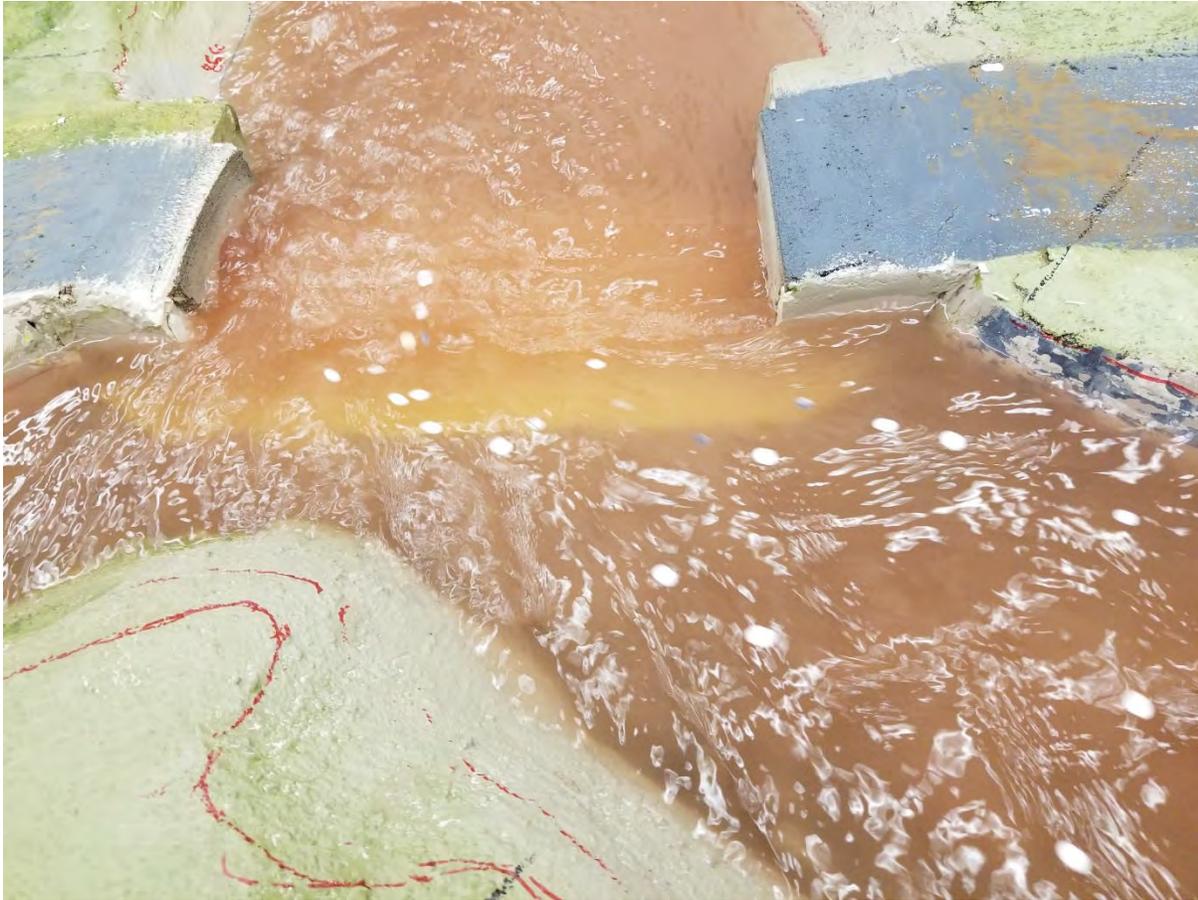
With the Road and culvert removed the flow is similar but the flow jet from Brush creek impinges nearly perpendicular in the left abutment. It would be anticipated that large erosional potential would occur there (Figure 4). As before in Runs 1 and 2 water levels in the immediate vicinity of the structure are lower but not significantly different elsewhere upstream or downstream. As before, the downstream channel is largely ineffective flow area on the right side of the channel.

Figure 4. Without the culvert and road a strong jet impacts the left abutment.

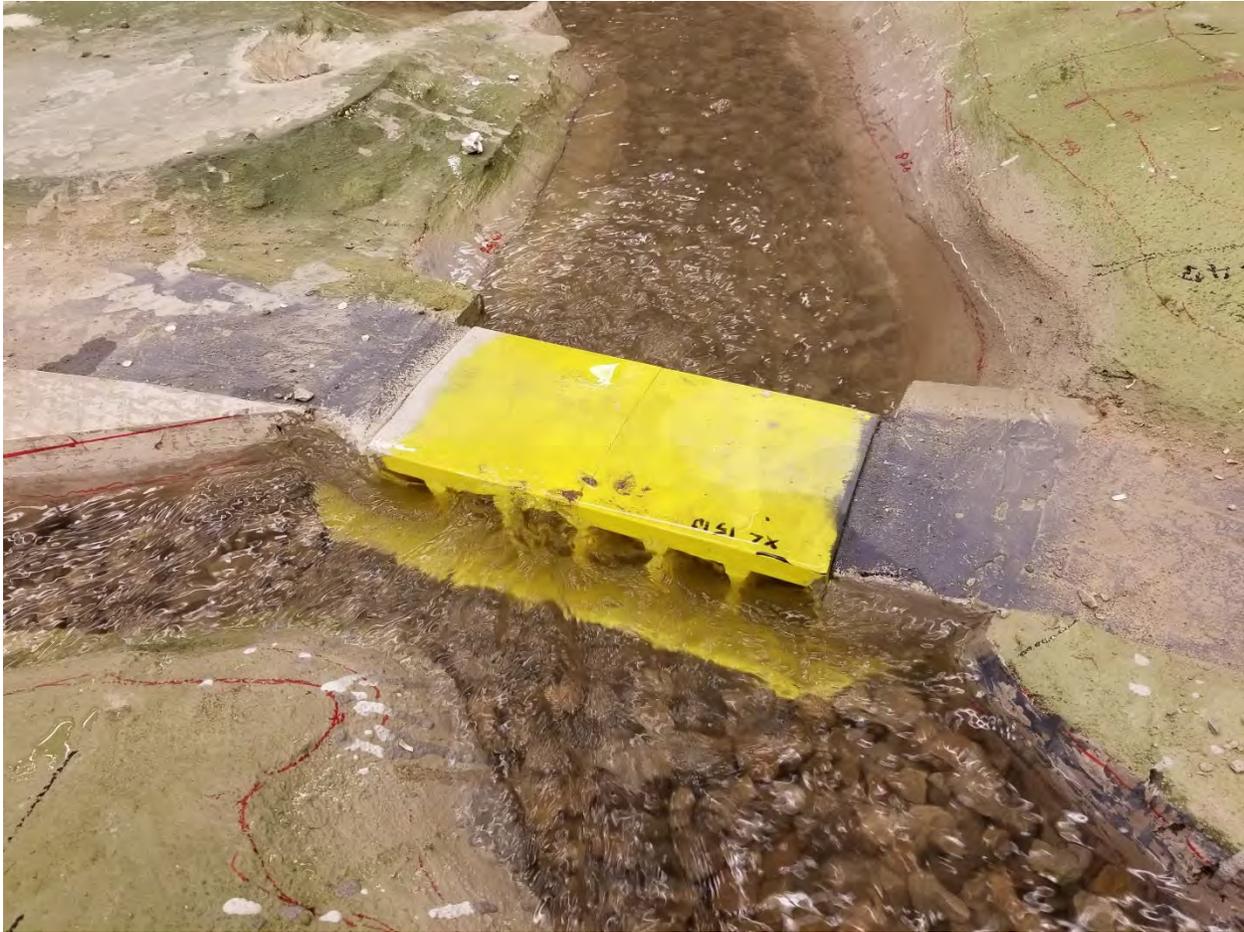
For this series of runs it was observed that both the Brush and Rock creek flows converged and flow through the weir structure nearly perpendicular to the weir (Figure 5). This observation was observed both with and without the road and culverts. As before removal of the bridge had minimal influence on water levels upstream and downstream of the structure. Downstream, the flow in the channel is fairly uniform with only a small area along the right bank where the flow area is ineffective.

Figure 5. At low flow water flows over the weir nearly perpendicular to the crest of the weir.

The Hydraulics of Run 4 represent a conditions that is desirable for this type of structure in that the flow over the weir is nearly perpendicular and the flow is directed parallel into the culvert barrels. This makes maximum use of the flow area of the culvert structure.

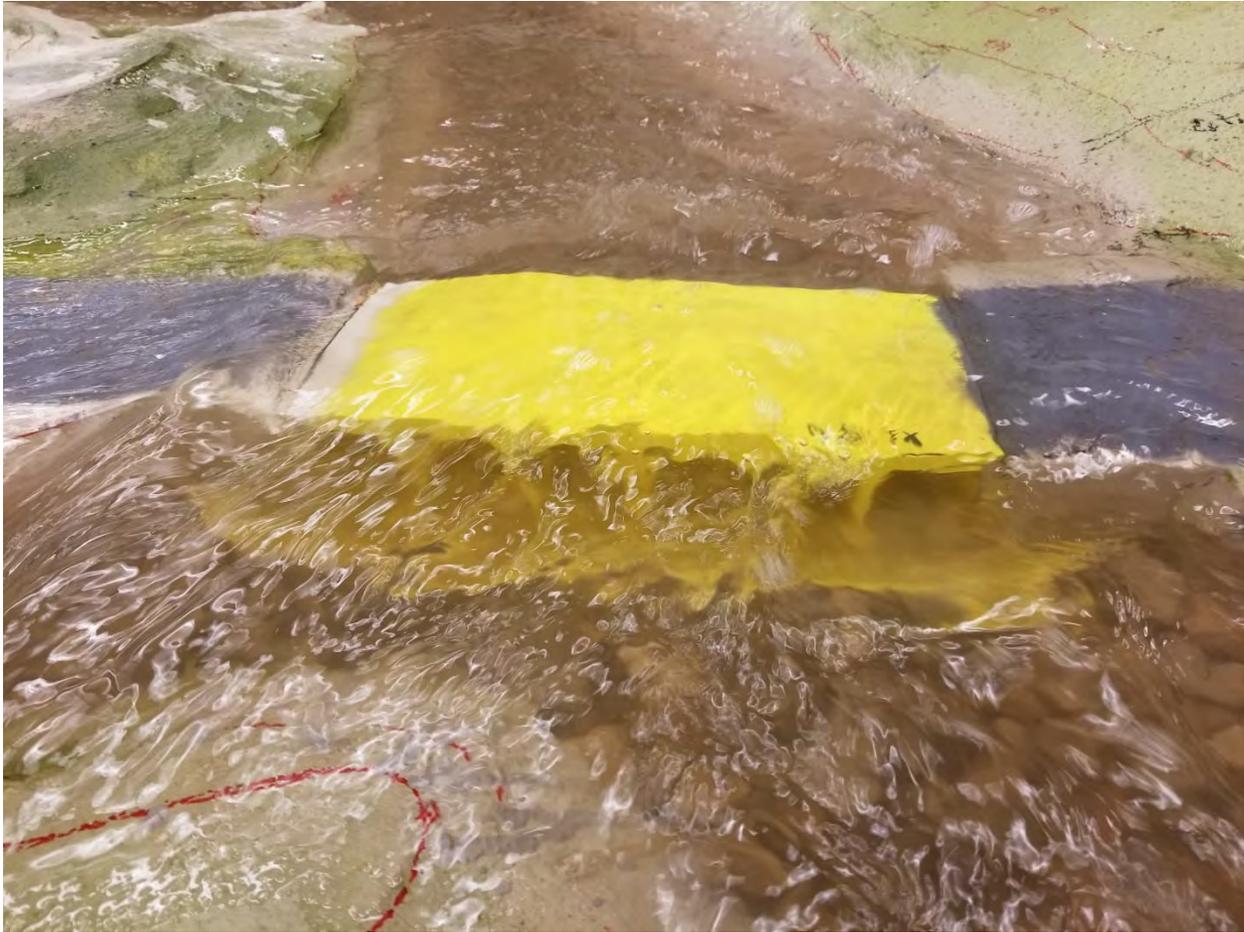
Significant overtopping of the roadway was observed for this case. The flow in the approach and over the road is unsteady and time variant and standing waves (Figure 6).

Figure 6. Run 6 for existing conditions shows a complex time variant overtopping flow with multiple locations having standing waves.
